Glass Surface Staining

To Our Valued Customer;

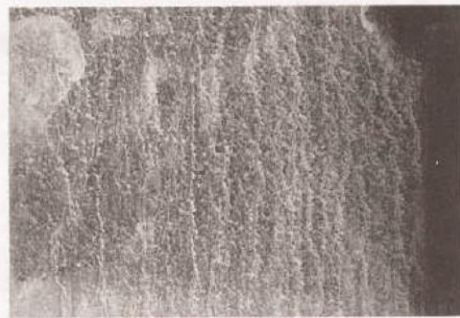
Figure 3 – Reaction Contaminant
Acid rain/masonry/glazing material
run-down on the glass surface.
Removal requires an acidic solution, or
may not be practically possible.

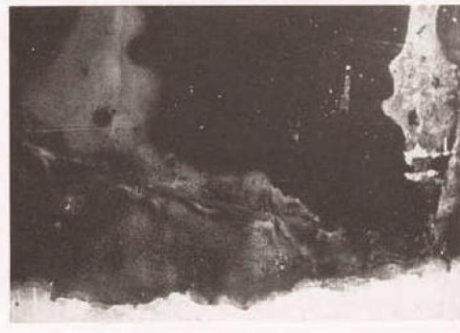
Figure 4 – Surface Corrosion
Glass corrosion is typically caused by
prolonged exposure to high humidity
and temperature and is often not
removable.
